Improving Southwestern Riparian Areas Through Watershed Management

Leonard F. DeBano and Larry J. Schmidt

General Technical
Report RM-182

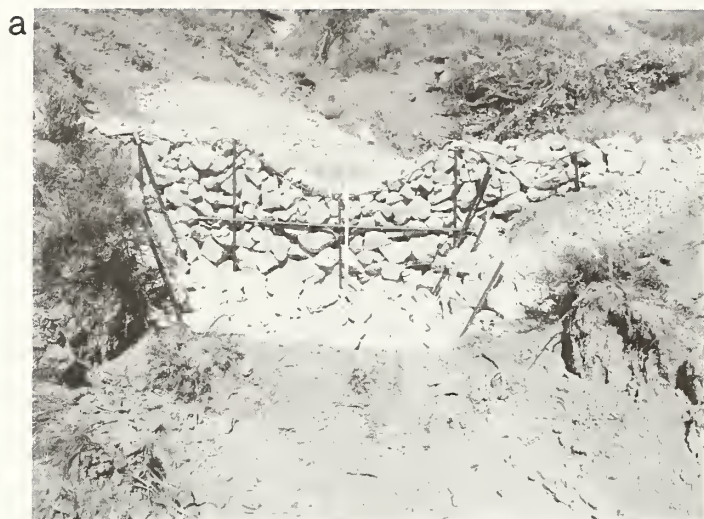
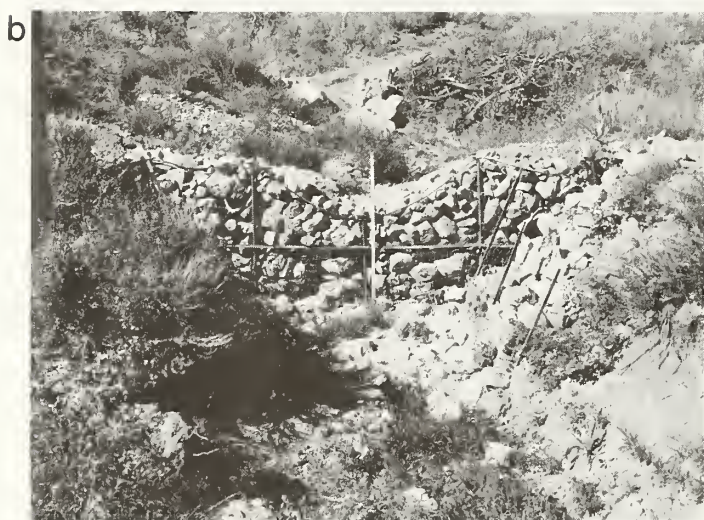
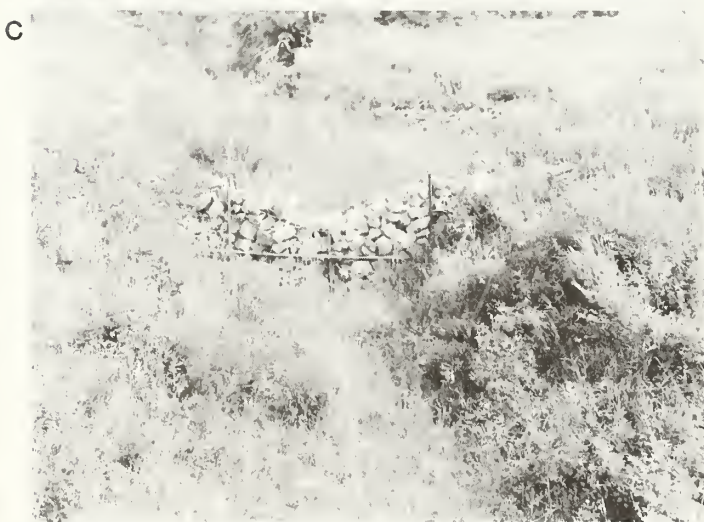
Figure 4.—An upstream view of a rock check dam constructed in an upper watershed channel on Alkali Creek in western Colorado: (a) immediately after construction in 1963, (b) in 1964, and (c) 12 years later in 1975. Notice the establishment of grass on channel banks and bottoms but the absence of riparian plants.

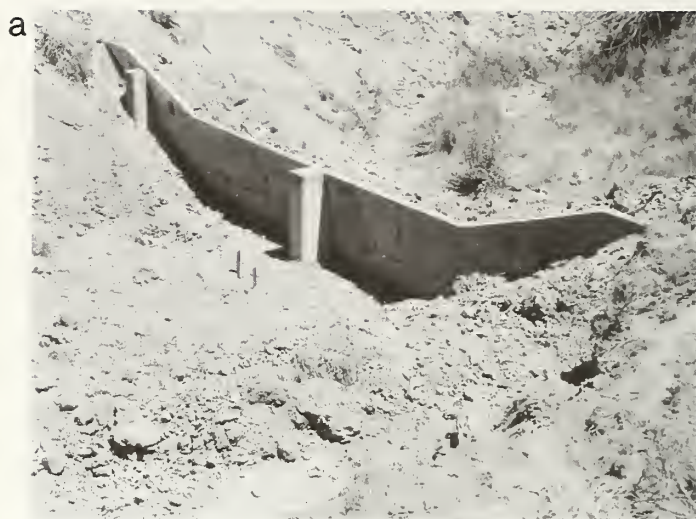
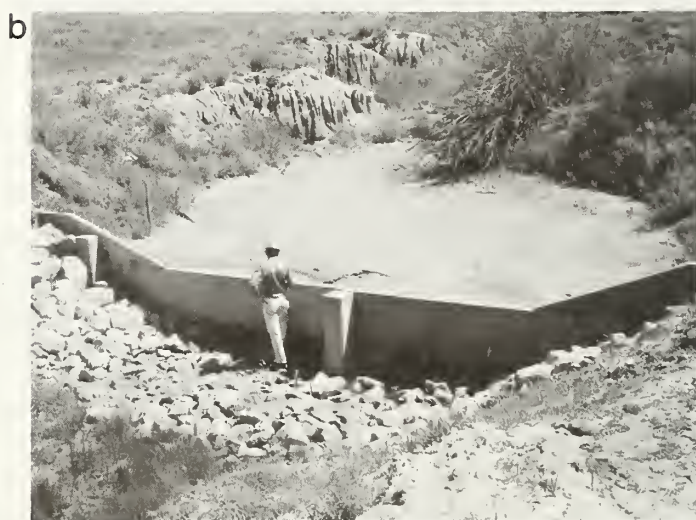
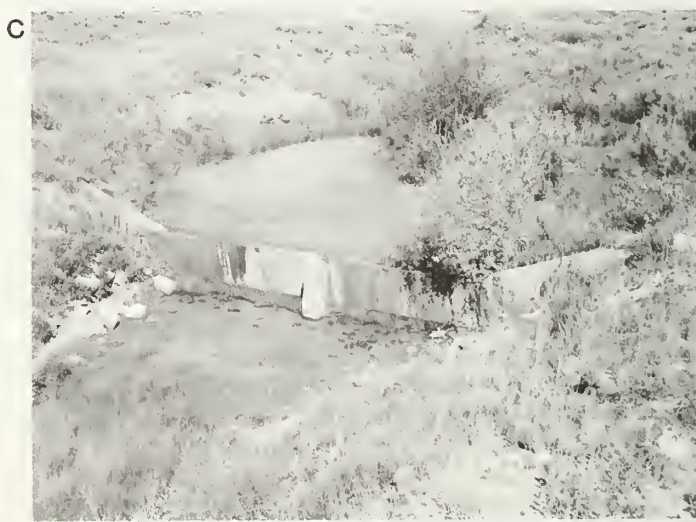
Figure 5.—The appearance of the site occupied by a larger gully control structure at the mouth of Alkali Creek in western Colorado: (a) immediately after treatment in 1963, (b) in 1964, and (c) 12 years later in 1975.

Prolonged streamflow at Alkali Creek allowed sedges and willows to become established, which enlarged into a dense riparian ecosystem by 1981 (fig. 5c). After the channel bottoms had become stabilized, riparian vegetation spread to the toe and lower segments of the gully sideslopes. Sediment deposits above the check dams prevented undercutting and loss of bank toes, and pro-

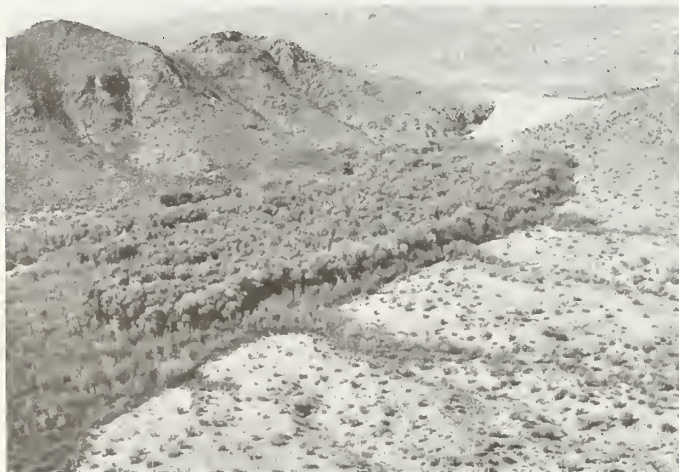
Figure 10.—A 79-acre riparian plant community above Whitlow Dam.

Case study.—A recent study of a flood control dam and reservoir in central Arizona illustrates how a large channel structure can alter streamflow and sediment regimes and enhance the establishment of a riparian ecosystem (Szaro and DeBano 1985). Whitlow Dam was built in 1960 as a flood control structure for temporarily delaying streamflow in Queen Creek by storing about 36,000 acre-feet of floodwater. The structure also stored sediment. By 1975, about 304 million cubic feet of sediment had been stored in the reservoir above the dam. Prior to construction, stream reaches above Whitlow Dam supported mainly Sonoran riparian scrubland (fig. 9a). There were no trees in the streambed, and adjoining banks supported mainly common mesquite, velvet mesquite, and ironwood. Only 7 years after completion, Gooding willow and saltcedar had occupied about 44 acres (fig. 9b). From 1967 to 1980, vegetation increased in both density and size to the 72-acre riparian community present today (figs. 9c and 10).

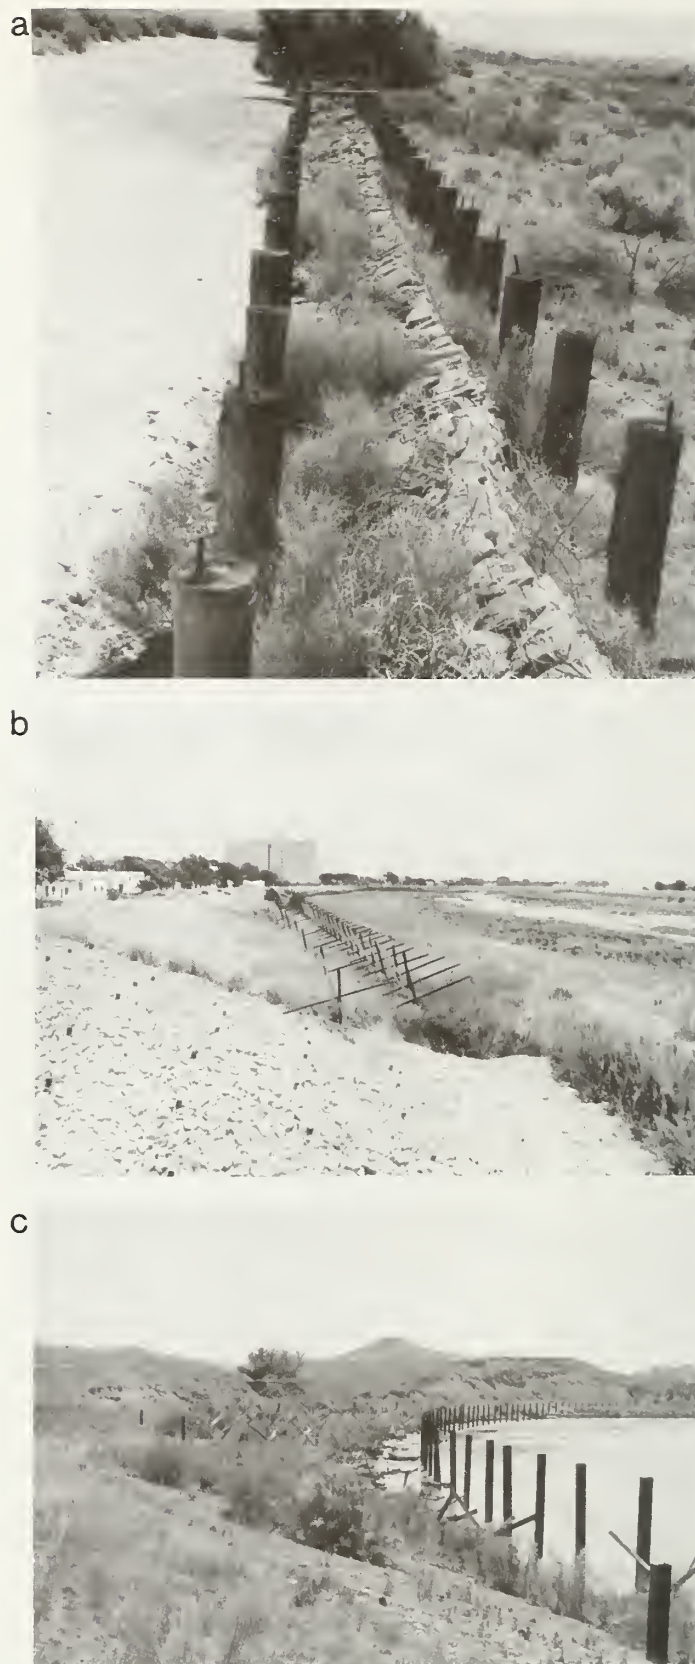
Figure 12. — Commonly used bank armoring and protection devices: (a) revetment posts and gabion near Moab, Utah; (b) jacks and bank armor at Dodge City, Kansas; and (c) jack field behind revetment posts on the Powder River, Wyoming.
